Montreux Waterfalls and Lakes Report

October 4, 2011

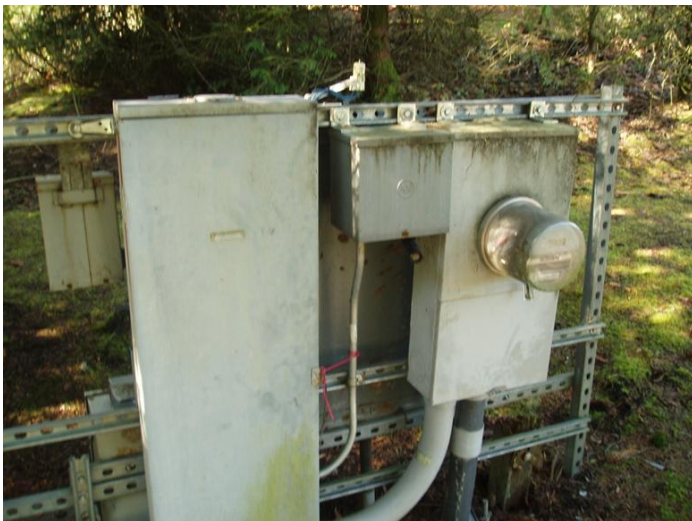
Photo 1. Rear view of old control panel showing power meter.

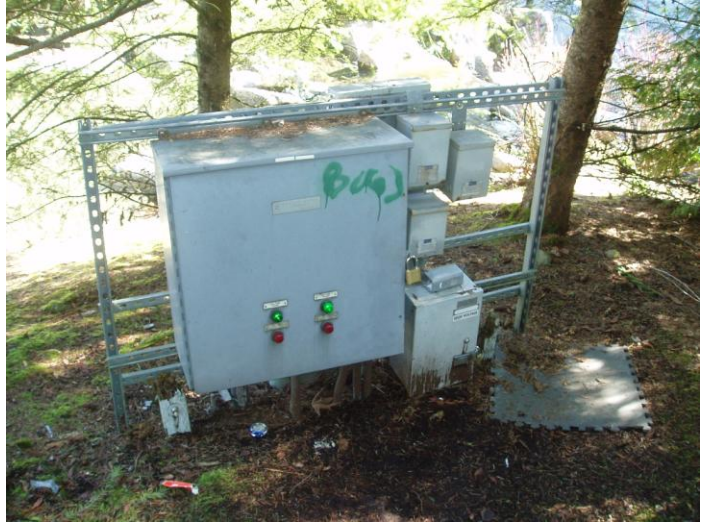
Photo 2. Front view of old control panel showing on/off lights for each pump.

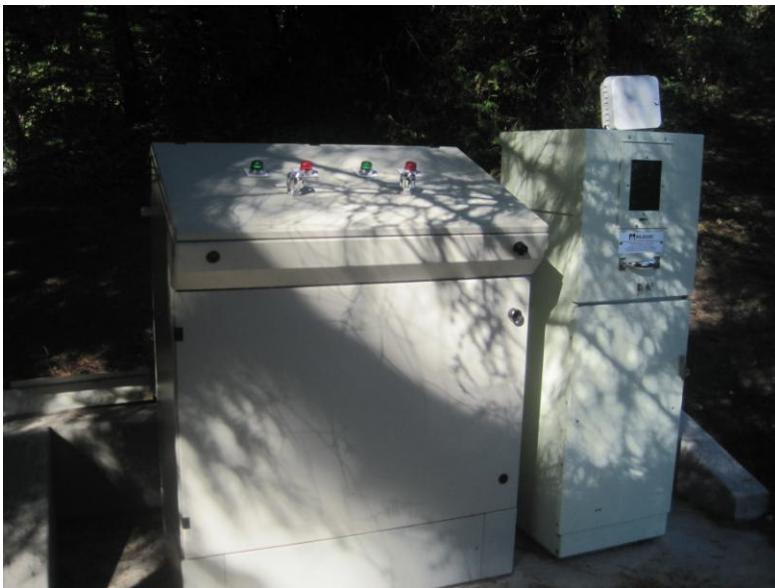
Photo 3. New control panel before building is constructed.

The new control panel is now installed, but all work is not yet completed. The Contractor went over our previously authorized limit of \$25K due to a couple of unanticipated site conditions and to some extras that we requested from him. An itemization of the extras are listed on the following page.

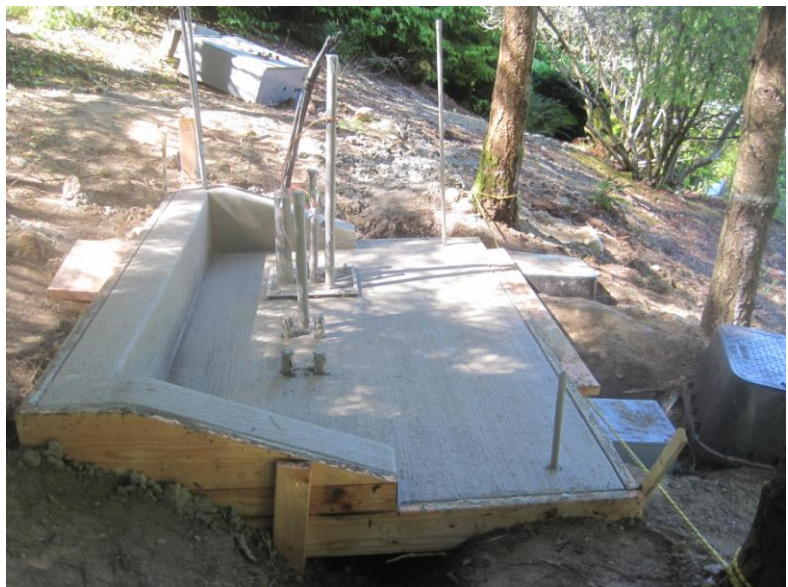
Photo 4. Concrete foundation for new control panel and building.

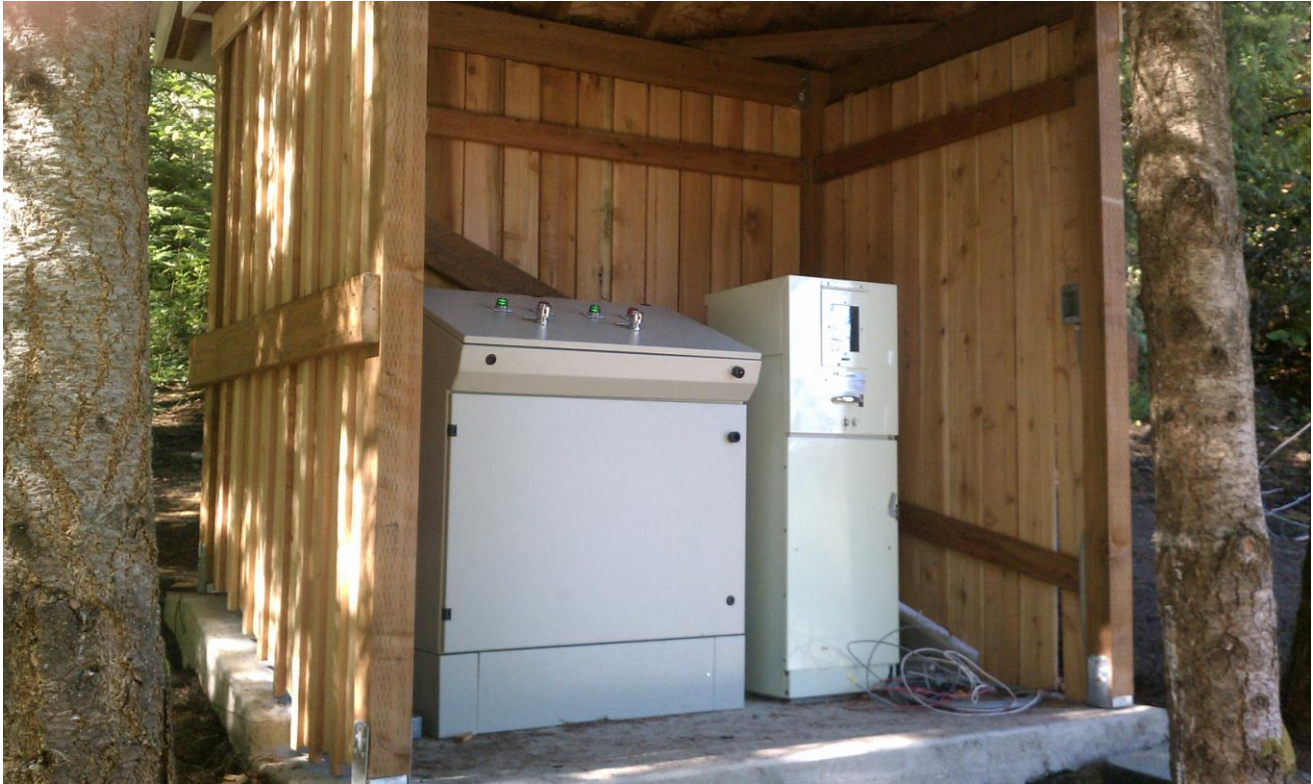
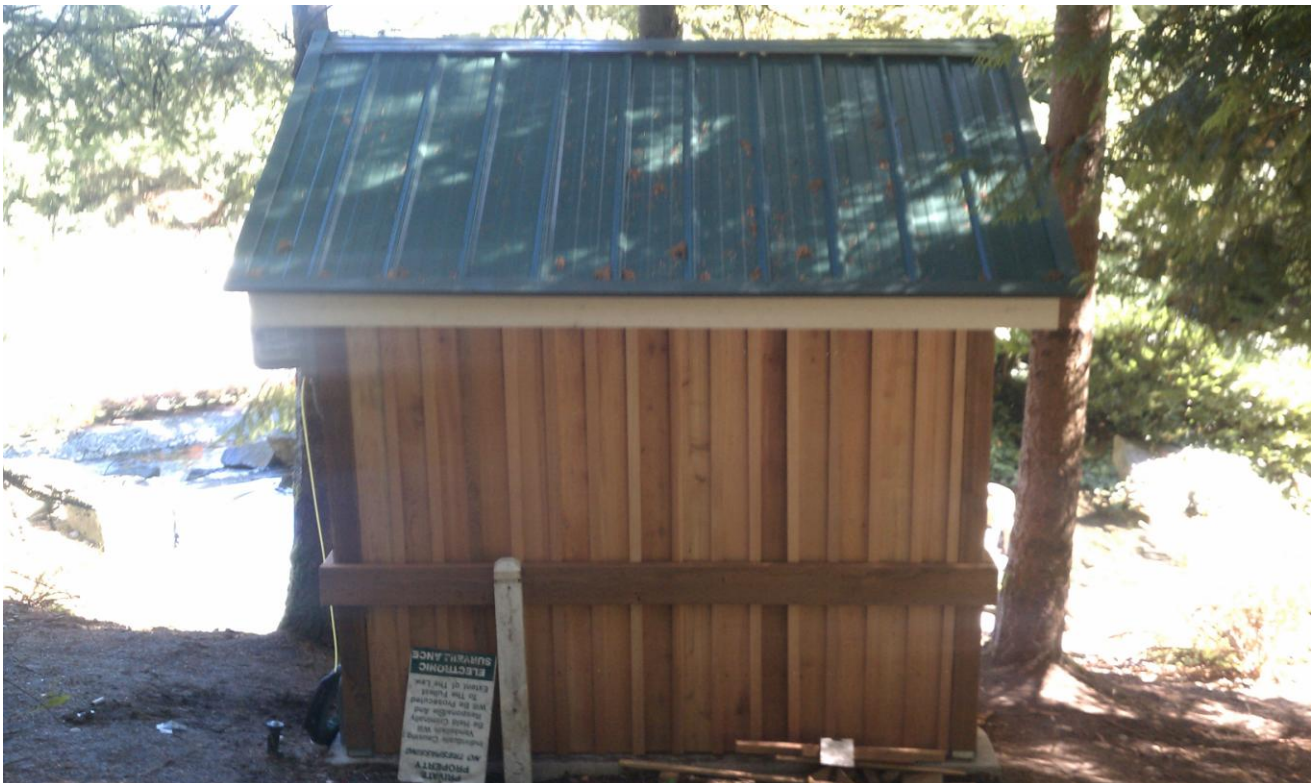
Photos 5 and 6: Front and back views of enclosure before rollup door is installed.

7. Enclosed the pole building with cedar siding and painting it \$720
8. Provided and installed a metal rollup door for the front of the enclosure \$790
9. Credit for the Pyramidalis that were on the original estimate -\$430
